**Florida Department of  
Transportation – District 4**

**Palm Beach County**

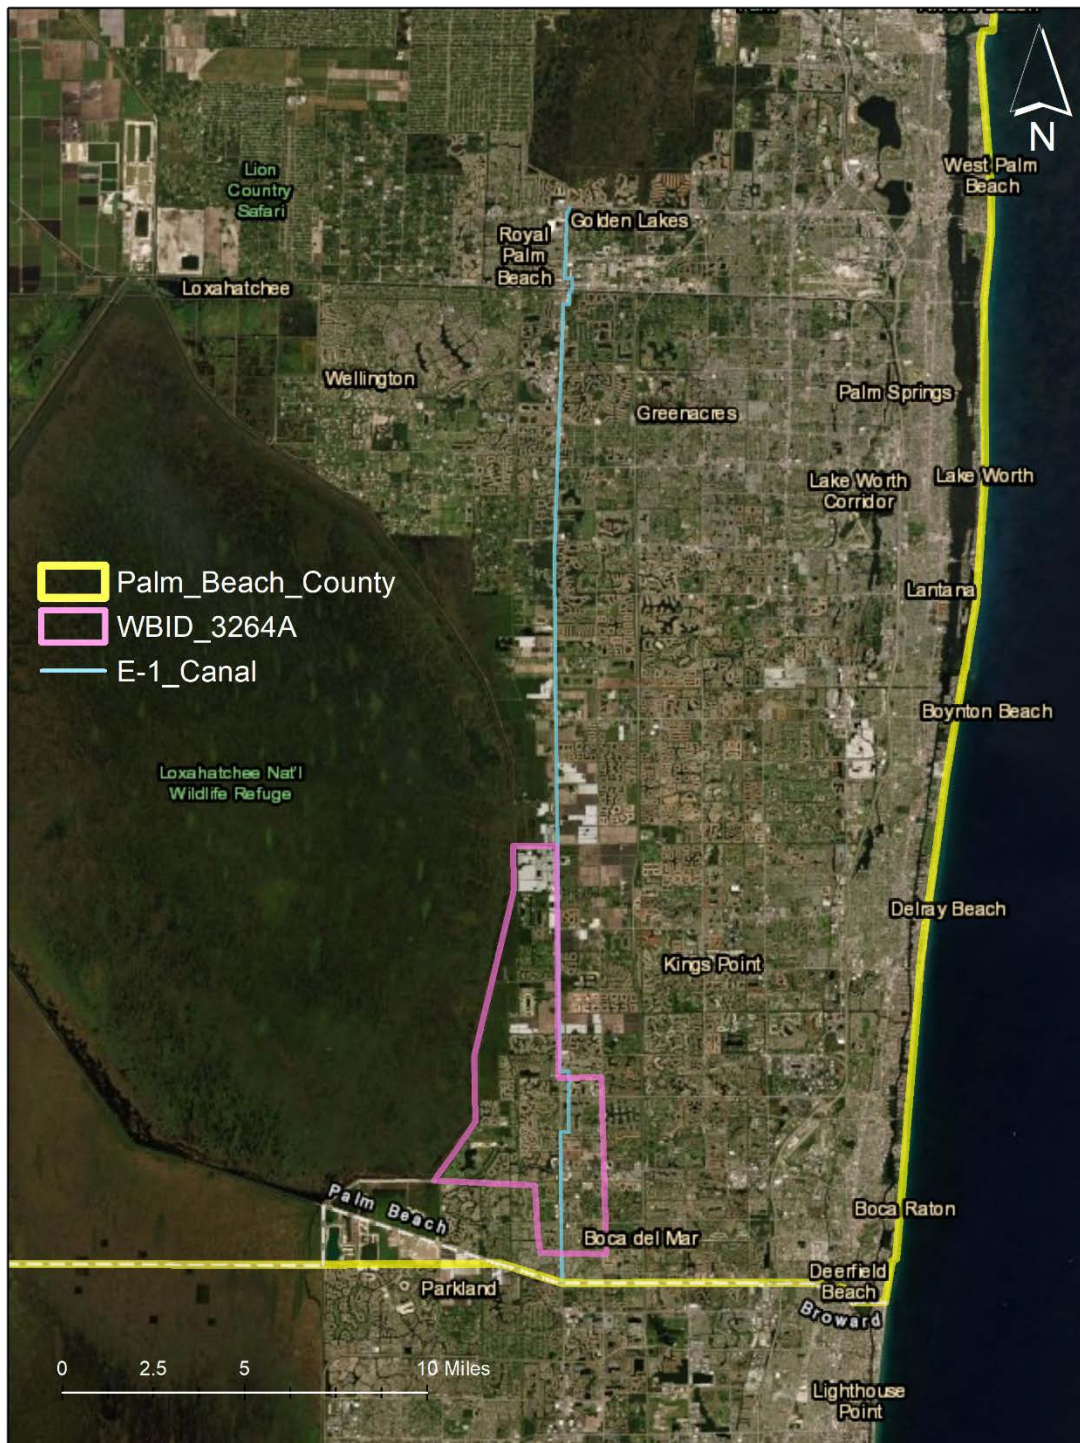
**Figure 1:** Overview of the E-1 Canal; the northern end is on the south side of Okeechobee Blvd., and the southern end connects to the Hillsboro Canal.

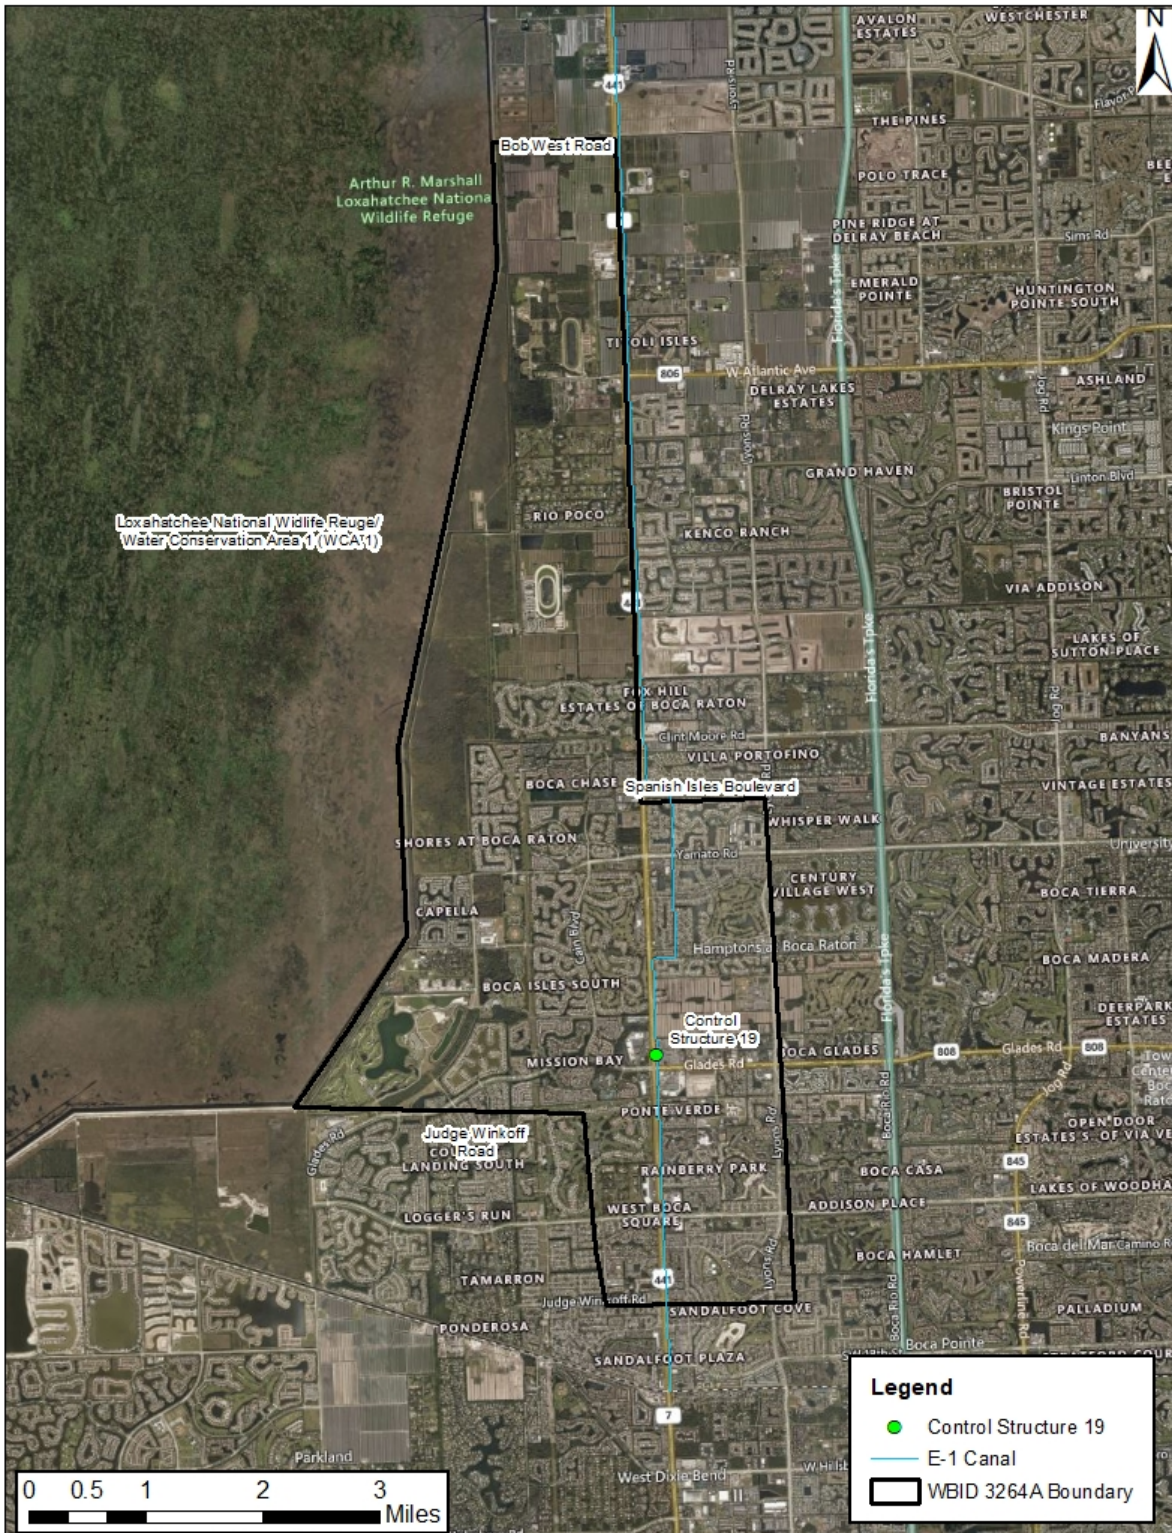
Figure 2: Map of WBID boundary, major roads and E-1 Canal.

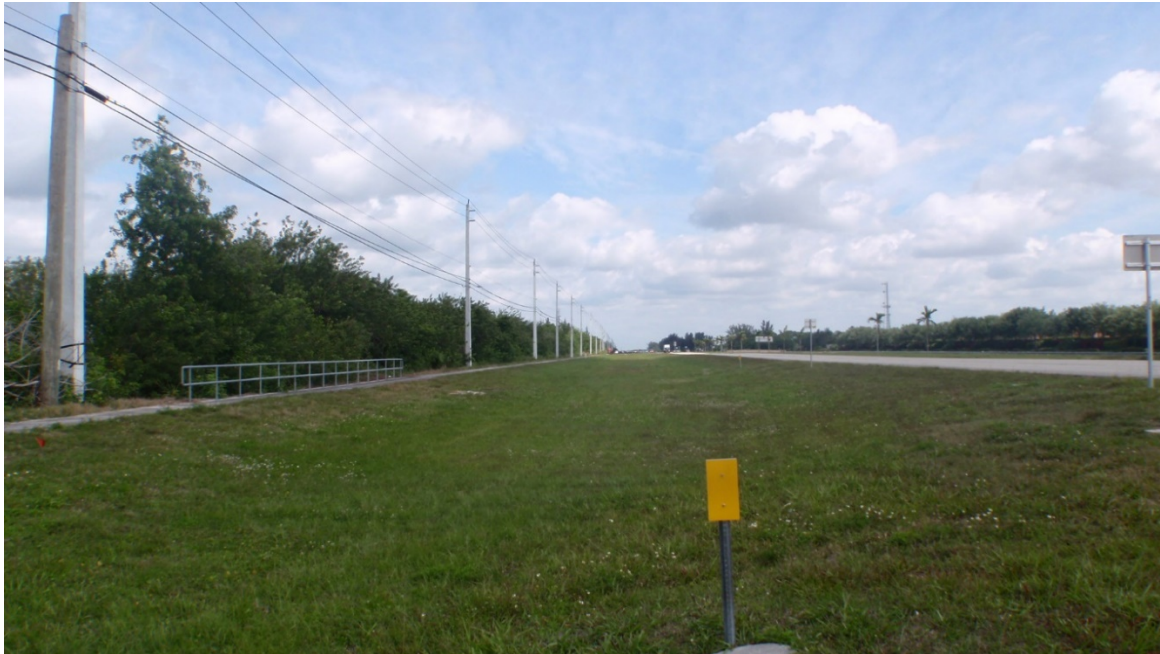
**Photo 1:** Typical swale on west side of SR 7, northern section of WBID (north of Yamato Road).

Field surveys of the WBID were conducted on April 2, 2019 and June 7, 2019. The results of these Walk the WBID surveys are discussed in more detail below in Section 3.3. Following are representative photographs (**Photos 1 – 7**) of typical drainage systems in the WBID.

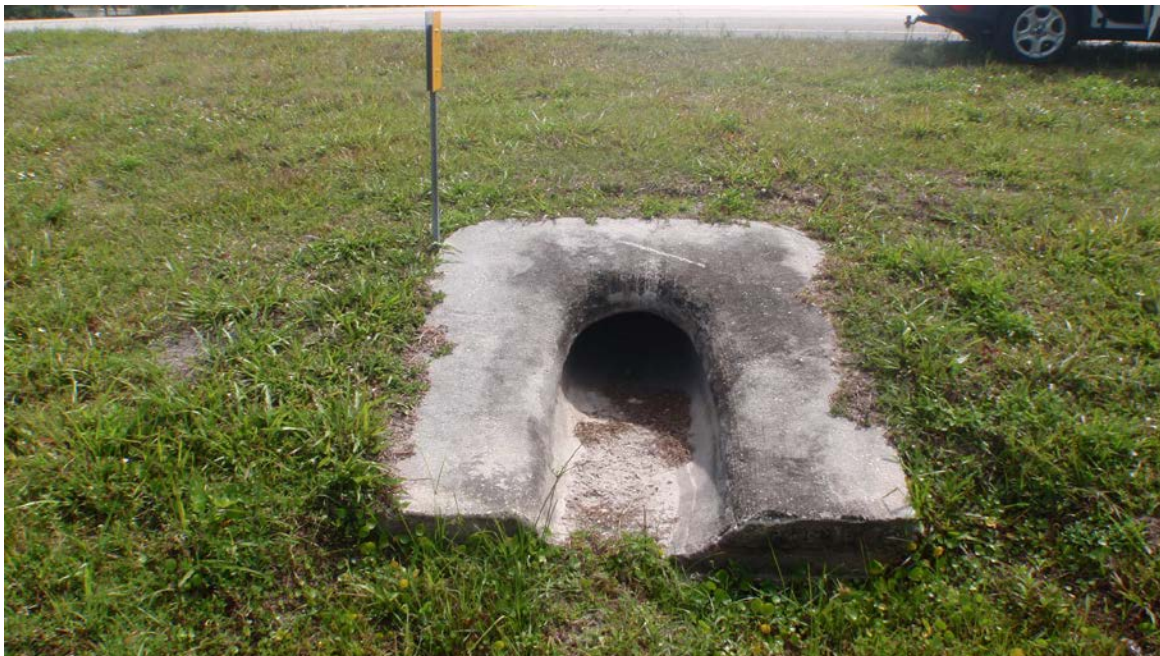
**Photo 2:** Typical mitered end section in swale on west side of SR 7, connected to culvert that runs east under SR 7 and discharges treated stormwater to the E-1 Canal.

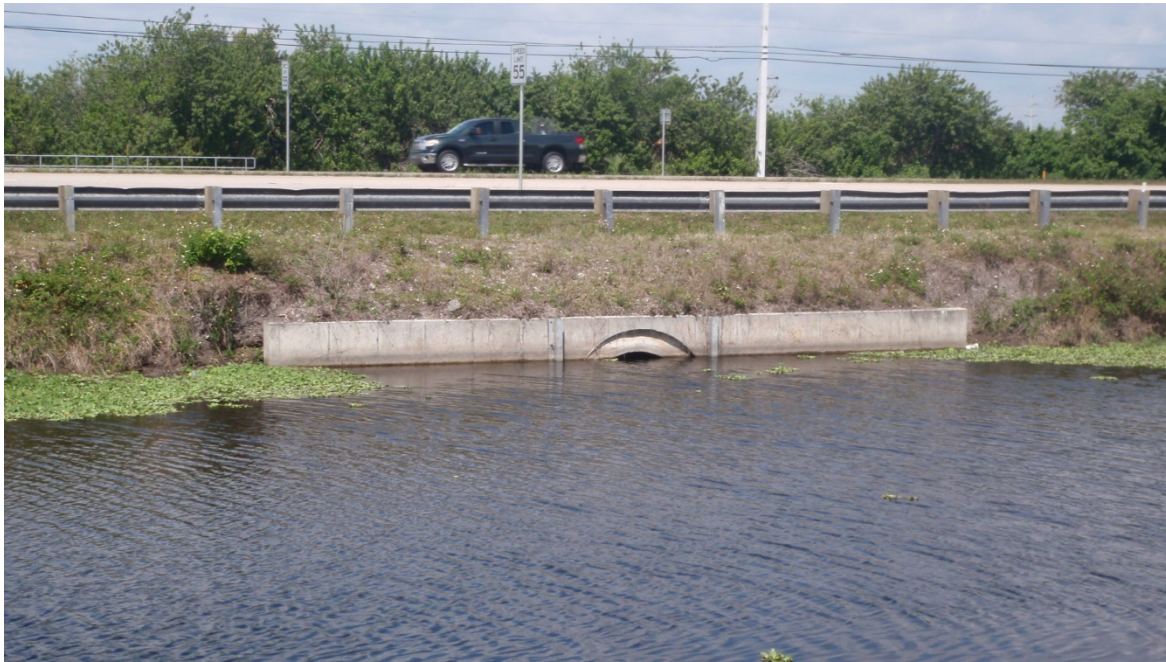
**Photo 3:** Typical FDOT outfall to E-1 Canal.

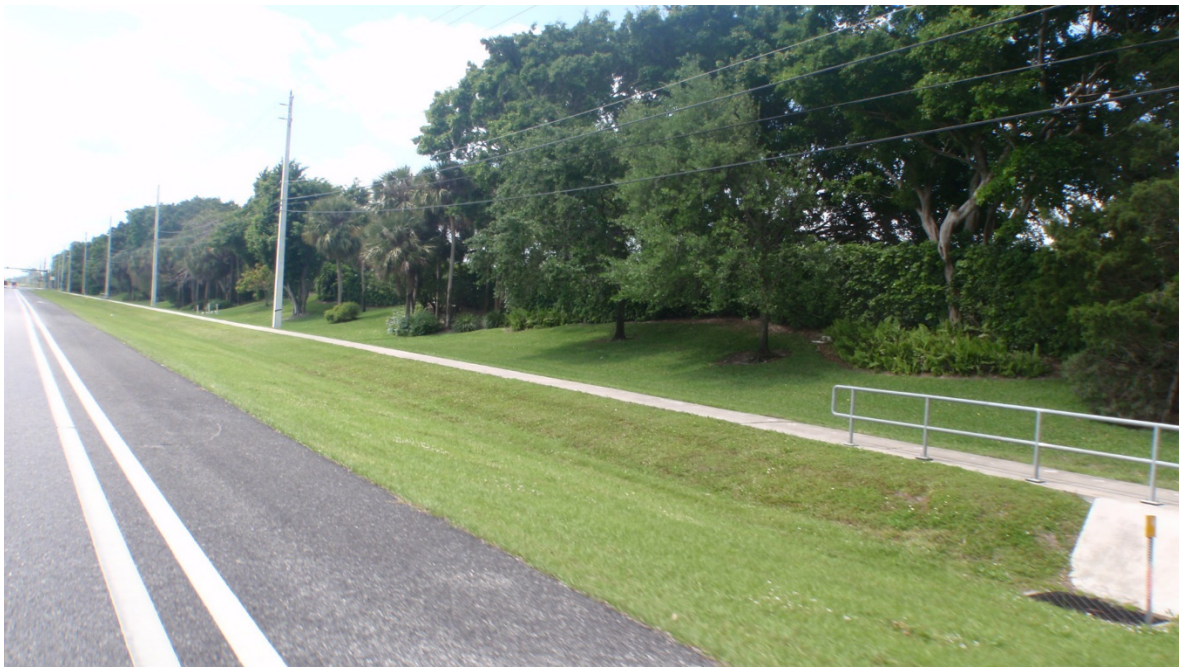
**Photo 4:** Typical swale on west side of SR 7 in southern section of WBID where west side of SR 7 are primarily single-family home communities separated from SR 7 by landscaped berms.

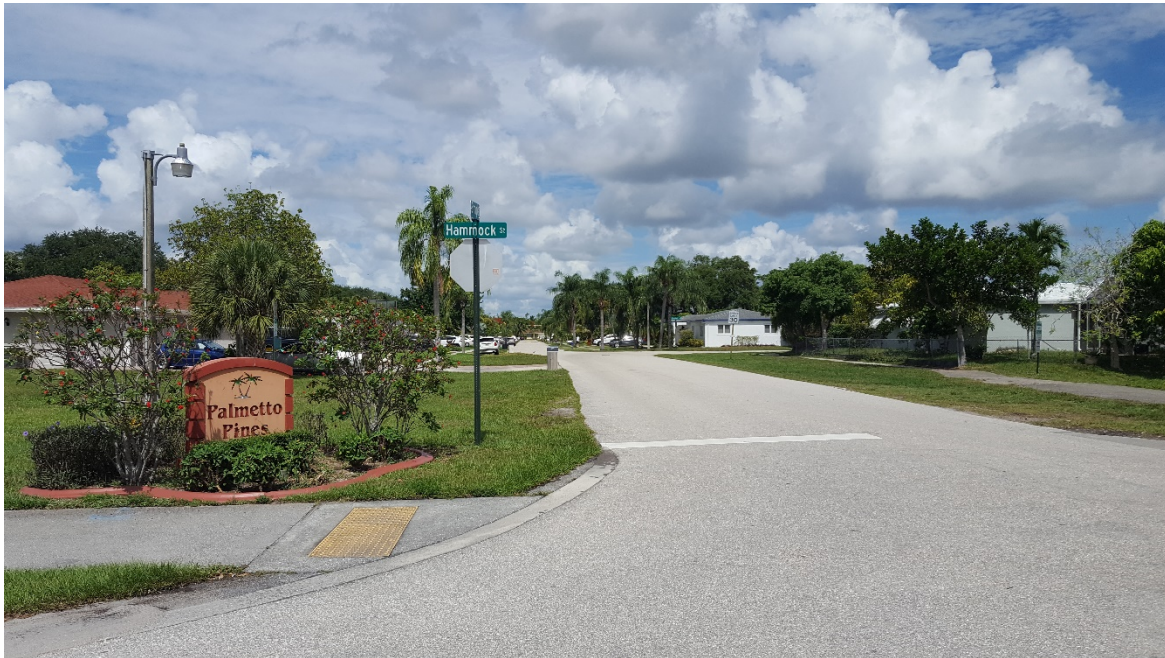
**Photo 5:** Typical neighborhood on sewer in southeast portion of WBID with stormwater Sheetflow to swales.

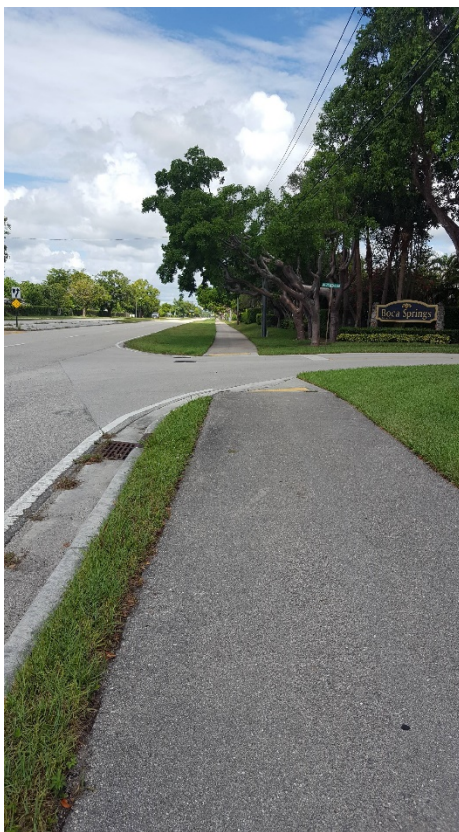
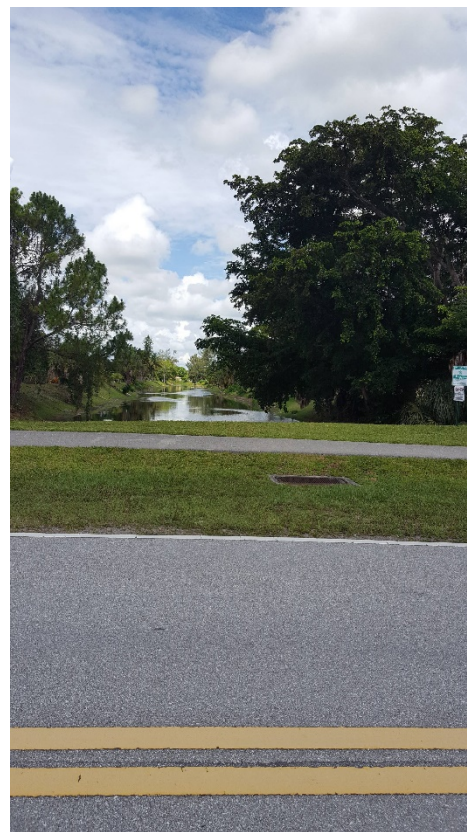
**Photos 6 and 7:** Typical curb and gutter (left photo) and typical inlet and canal system (right photo) in southern portion of WBID.

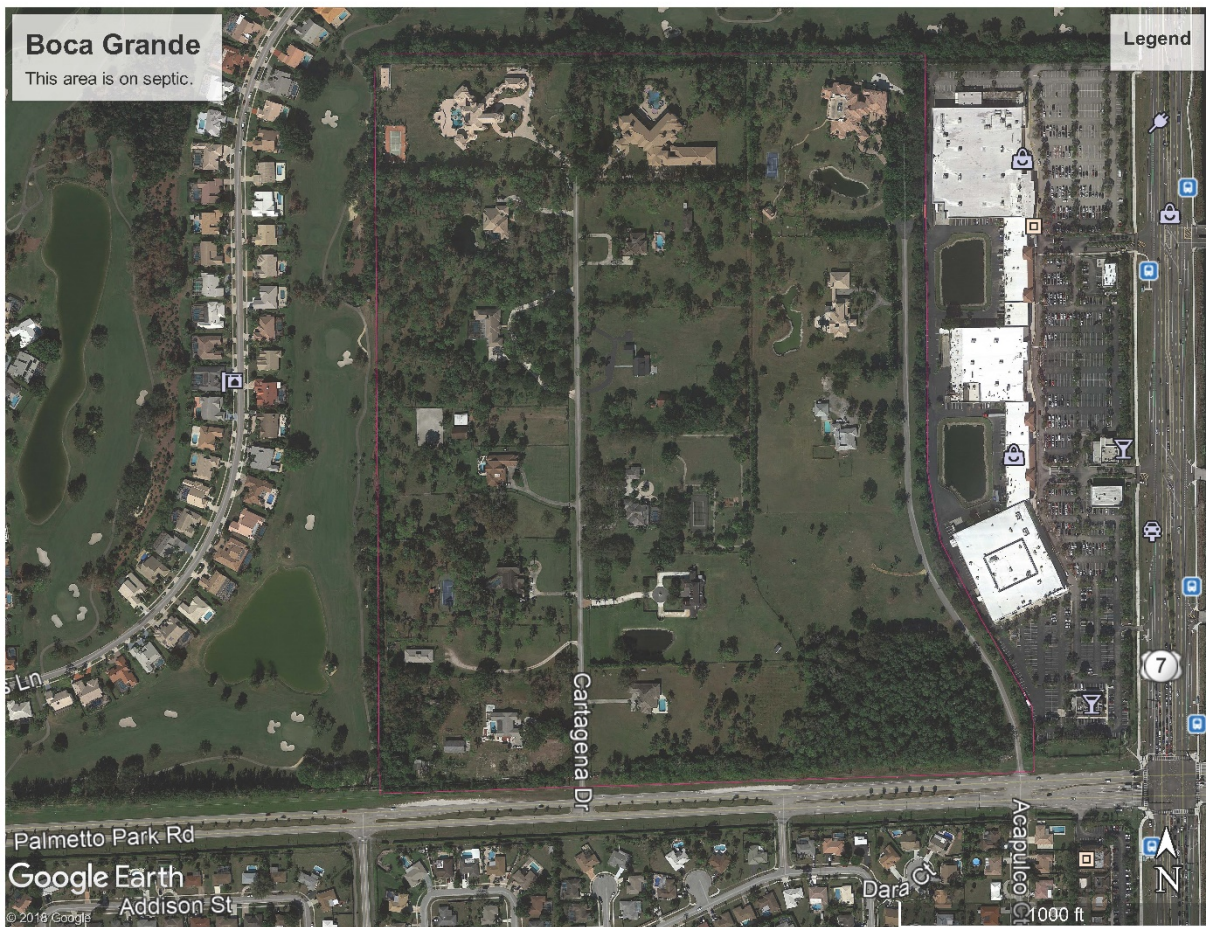
**Photo 8:** Aerial view of neighborhood on septic.

In the southern portion of the WBID that does drain to the E-1 Canal are two areas still on septic shown below in **Photo 8**:

1. The Boca Grande neighborhood located approximately one-quarter mile west of SR7, on the north side of Palmetto Park Road. There are 16 homes here spread over 90 acres. Although this area does eventually drain to the E-1 canal, based on the distance from the E-1 Canal, and the large lot size (5 or more acres per home), it is unlikely this neighborhood contributes bacteria pollution to the E-1.

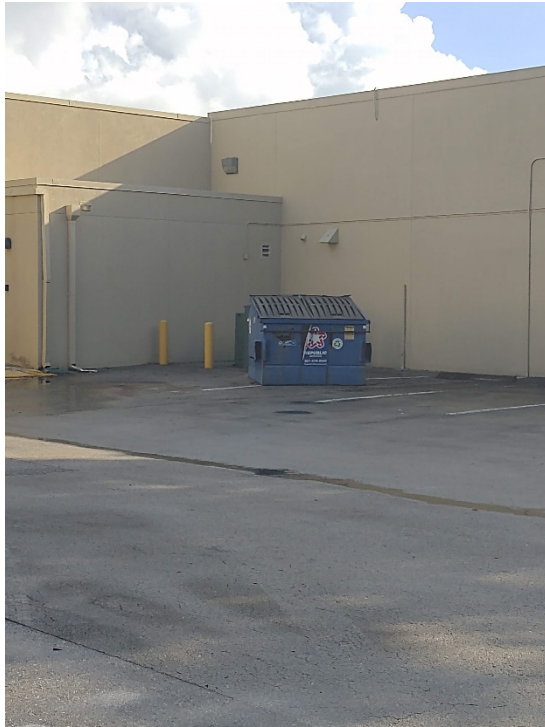
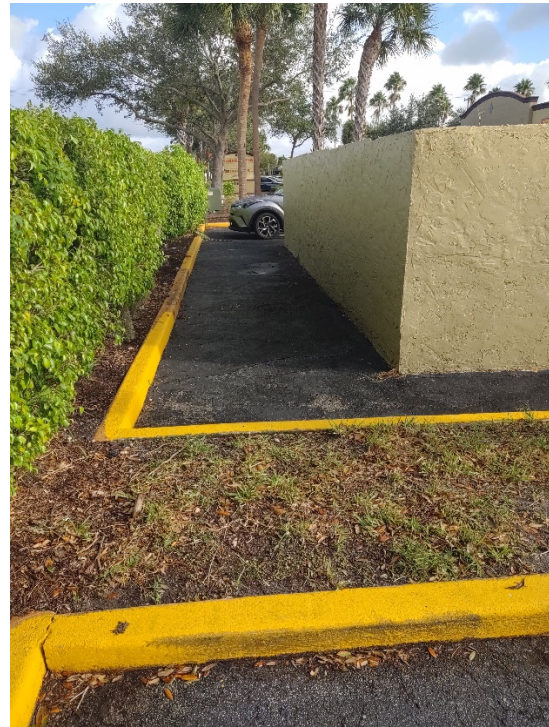
**Above: Photos 9A (left) and B(right):** Typical well-maintained dumpsters/dumpster area behind shopping centers.

No significant signs of litter or debris were noted along the roadways or in the commercial or residential areas. During the Walk the WBID exercise, dumpsters from various commercial areas were inspected, and the majority were well maintained with the lids closed and drains plugged. However, the dumpsters located between the West Boca Medical Center and the E-1 Canal were overflowing and could not be closed. Palm Beach County alerted the hospital about this violation and will follow-up. Some farm equipment was observed adjacent to the west side of SR 7, but there was no connection to the FDOT right of way. Drainage west of SR 7 in this area is to the west, not to the E-1 Canal. Also, a recent study performed by Environmental Science Associates demonstrated that grass clippings can present a significant source of bacterial contamination to our waterways (Tomasko, 2016). Therefore, the Walk the WBID exercise included looking for signs of leaf and/or vegetative debris in gutters and/or rights of way adjacent to roadways. Only minor vegetation was observed in the curb and gutter. During the site visit, roadway crews were actively picking up litter along the right of way. See photos below related to these observations.

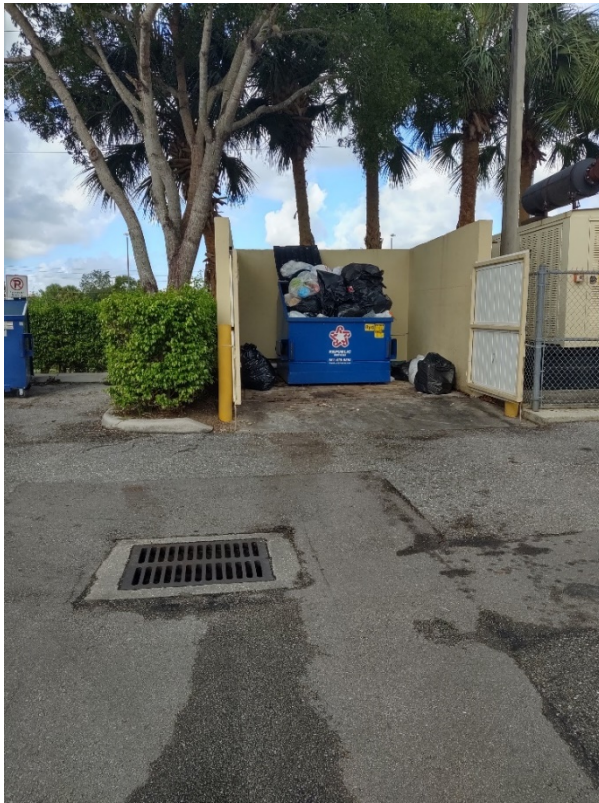
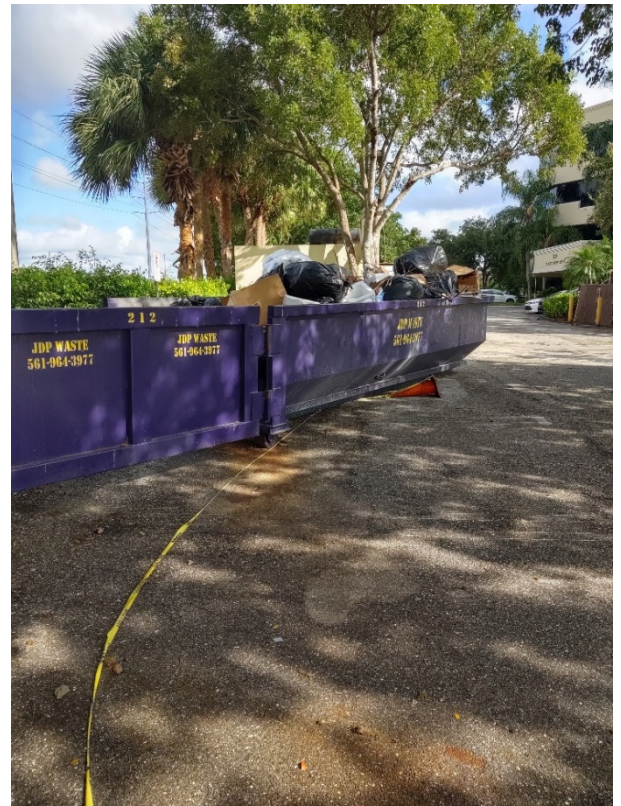
**Photos 10A (left) and B (right):** Dumpsters behind Medical Center.

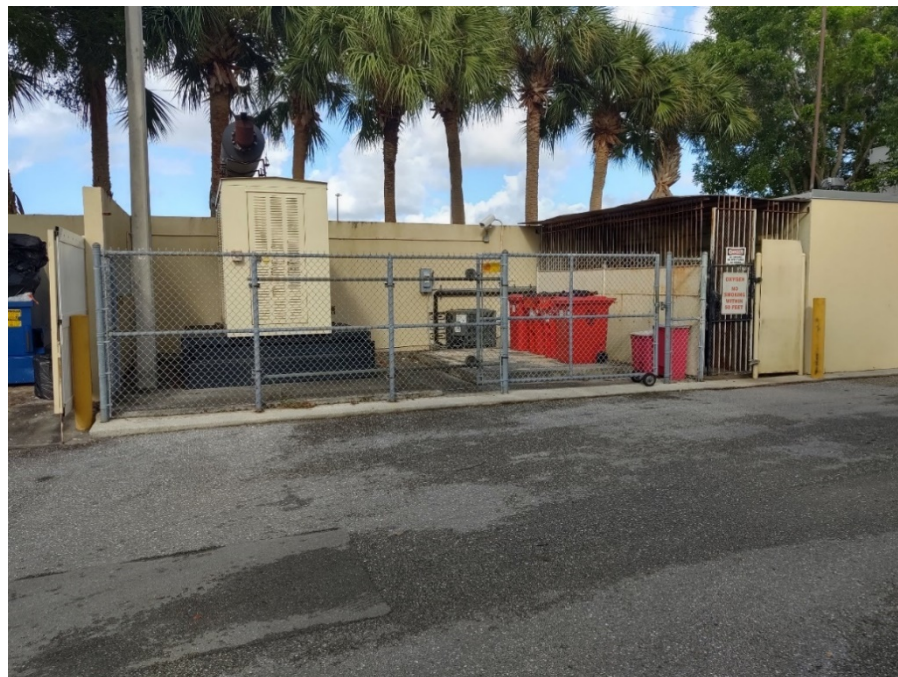
**Photo 11:** Medical waste dumpsters behind locked gate behind Medical Center.

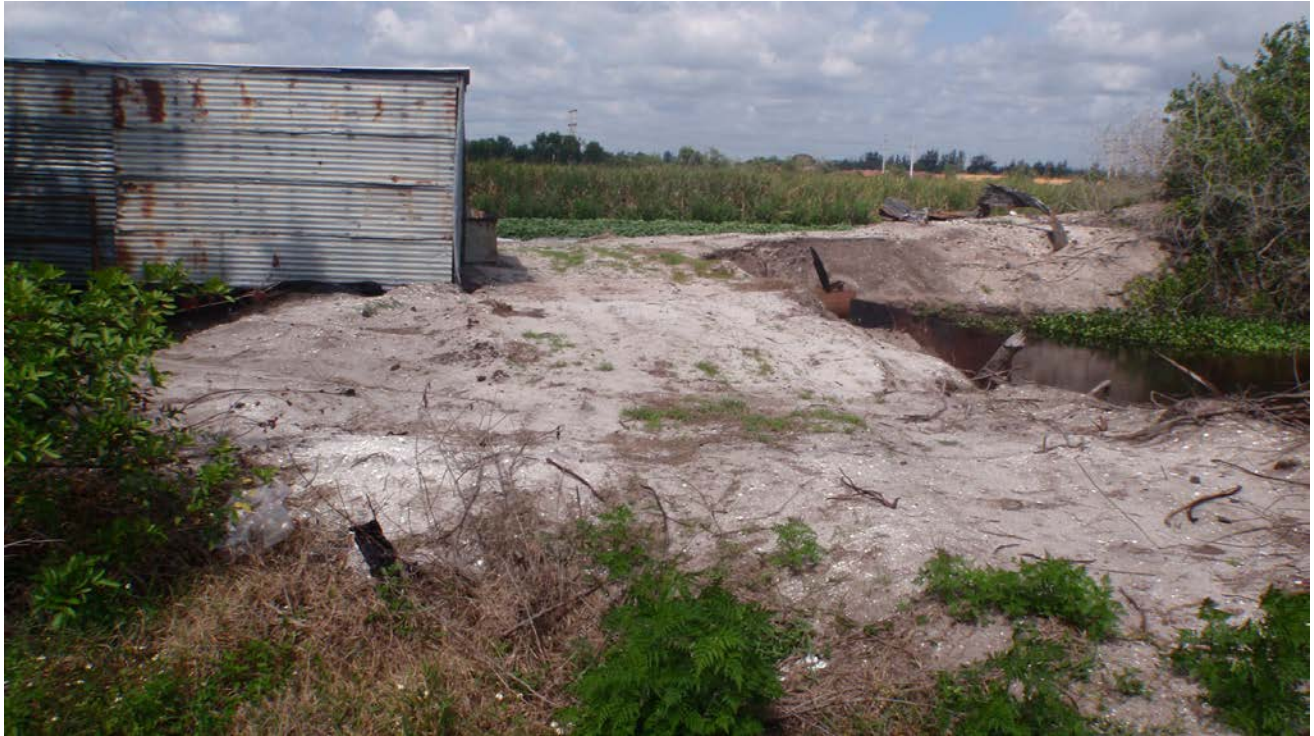
**Photo 12:** Farm equipment west of SR 7; there was no connection to SR 7 right of way, and this area drains west.

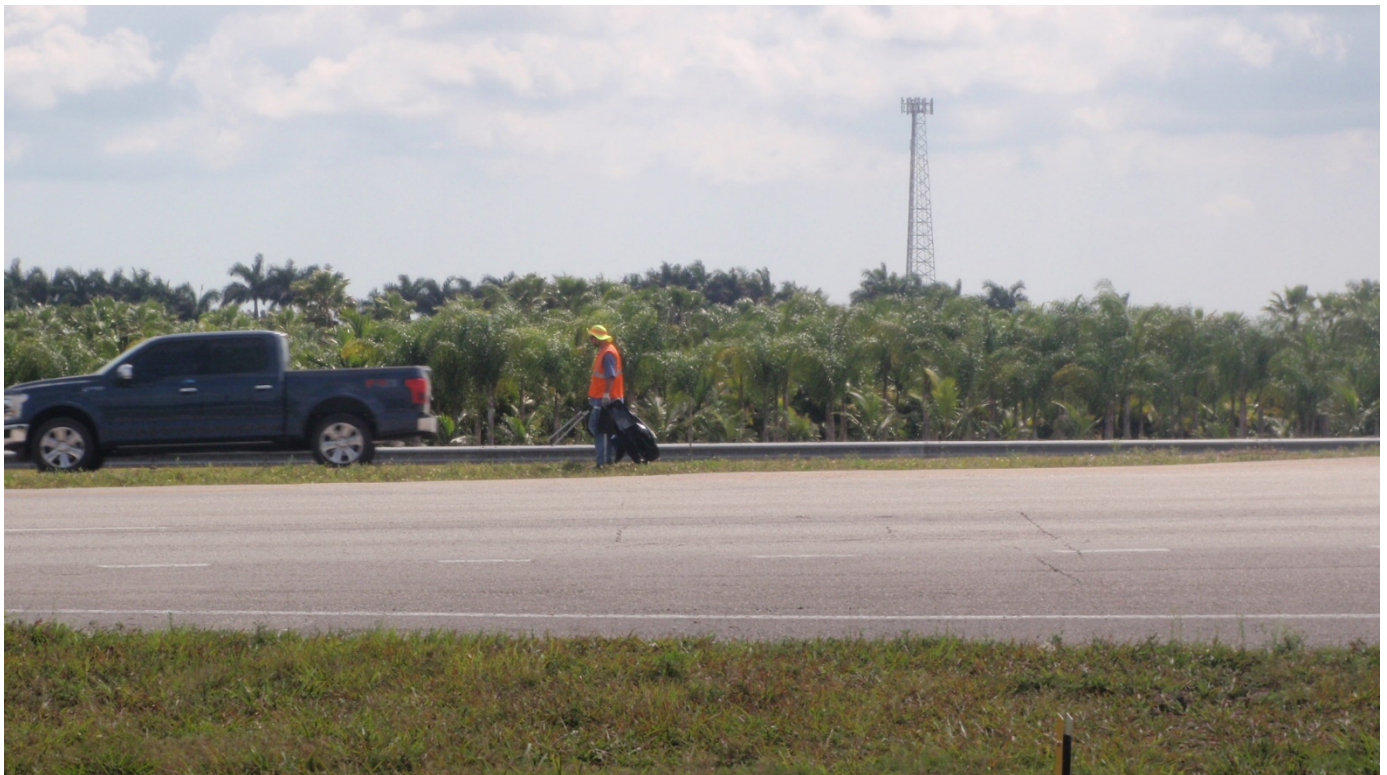
**Photo 13:** FDOT contract workers picking up trash along SR 7; E-1 Canal is beyond guardrail.

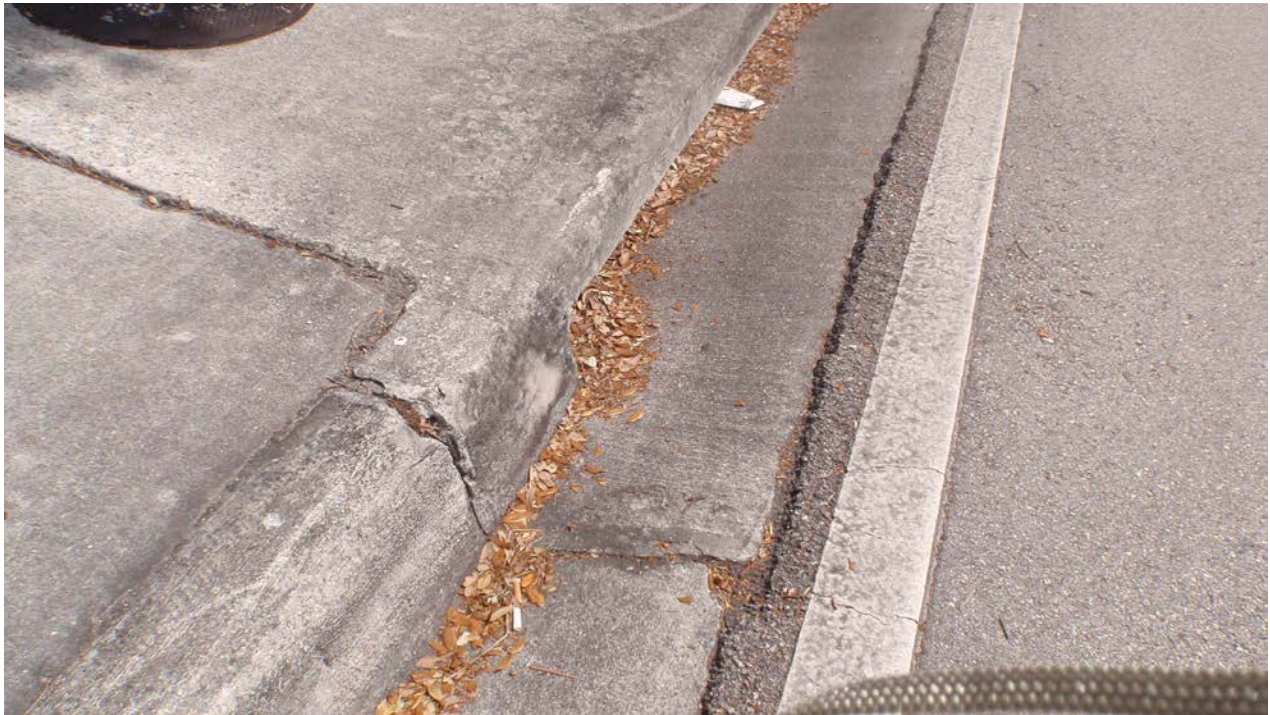
**Photo 14:** Minor vegetative debris observed along roadways.

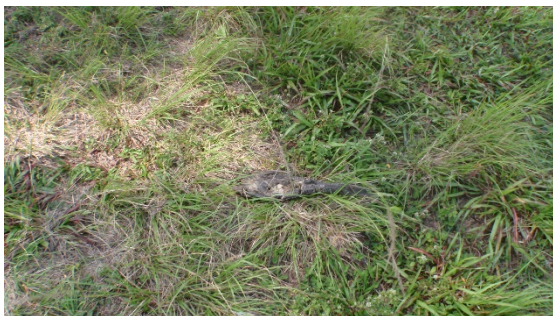
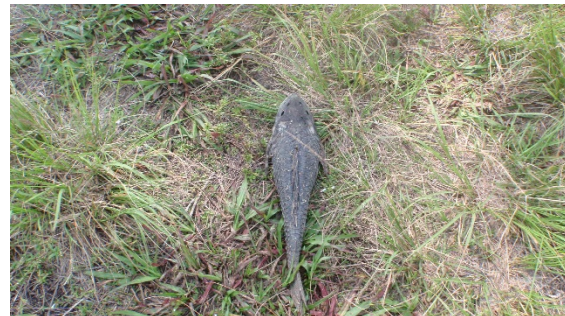
**Photos 15 A (left) and B (right):** Dead fish left along east bank of E-1 Canal, presumably from recreational fishing activities.

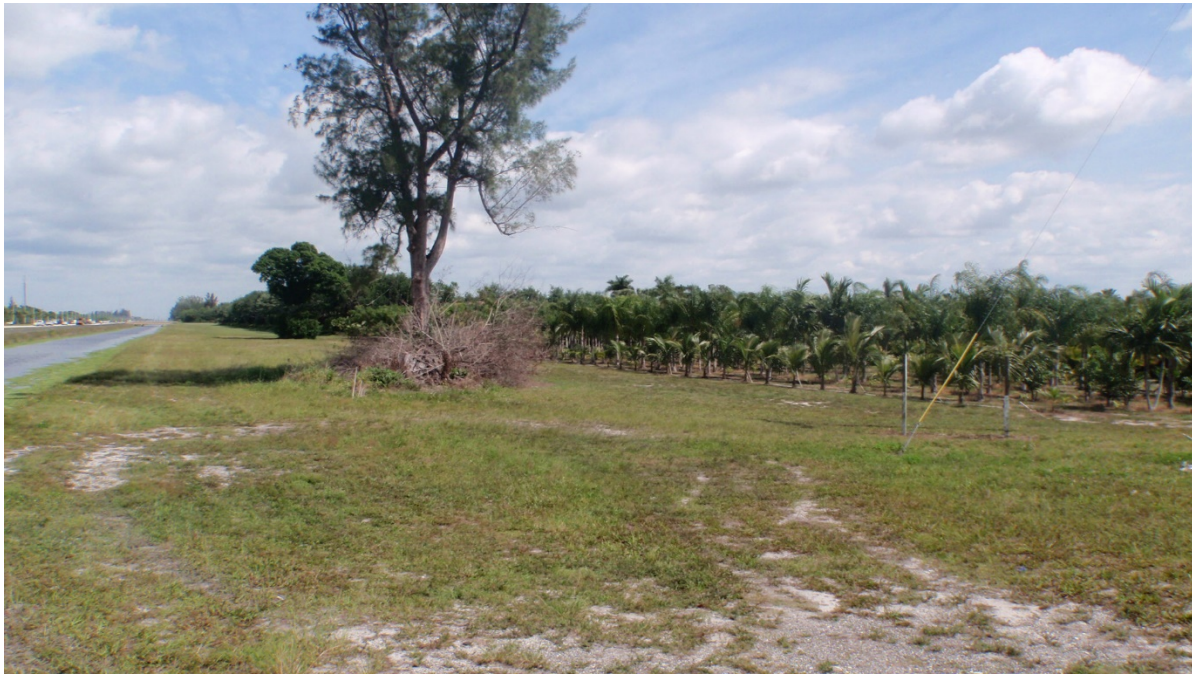
**Photo 16:** Facing north at SR 806, view of E-1 canal and adjacent tree nursery that drains to east. Typical of well-maintained swale on east side of E-1. SR 7 can be seen in background on far left side of photo, west of the canal. (Note: area east of E-1 canal is actually outside WBID boundary.)

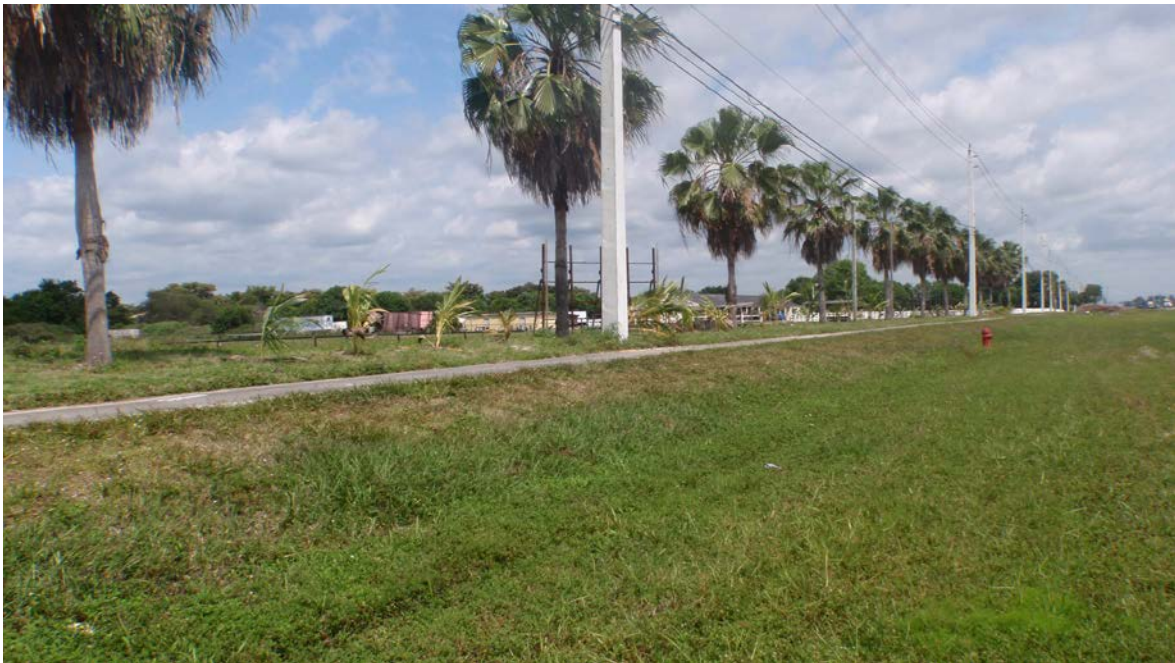
**Photo 17:** Typical swale in northern portion of WBID on west side of SR 7 between road and agricultural lands. The agricultural lands in this section of WBID drain west, not to the E-1 Canal; however, the swale treats stormwater from SR 7 and drains east to E-1 canal via series of culverts under road (see Photos 2 and 3above.)

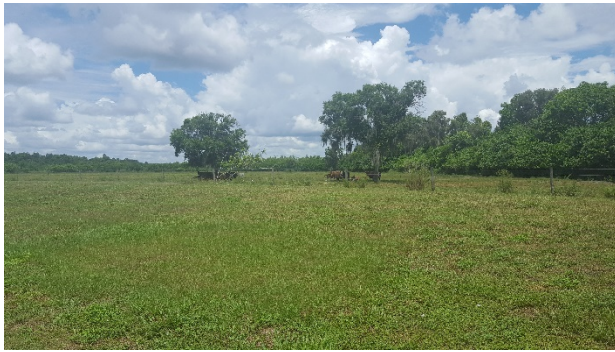
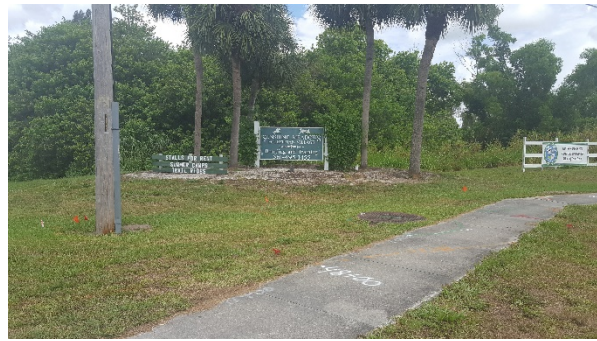
**Photos 18 A (left) and B (right):** of pastureland and entrance to horse farm in northern portion of WBID; this area drains to the west, not to the E-1 Canal.
