Phase I Municipal Separate Storm Sewer System (MS4) NPDES Stormwater Audit Report

MS4 Permit Name:	Palm Beach County
Permittee:	Village of Palm Springs
Permit Number:	FLS000018 (Cycle 4)
Annual Report Year:	Year 1
Reporting Period:	10/01/2016 - 09/30/2017
Audit Date/Time:	June 7, 2018 7:45 am – 12:00 pm

Village of Palm Springs MS4 Year 1 Audit Report Page 2

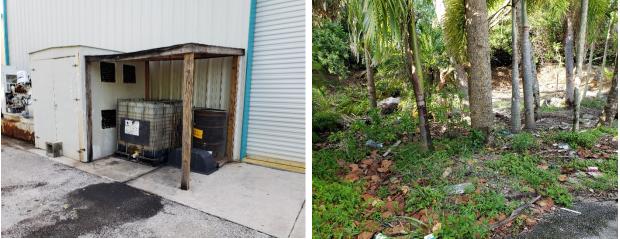
Observations: Fleet maintenance and storage onsite. Parking lot was clean, no catch basins noted. Site drained to a low-lying area at back of property. Noted some erosion and trash in low area. Used oil and filters were stored under cover, but did not have secondary containment. Paint was stored indoors and in secondary containment. Equipment was stored under cover.

Image 1: Used Oil Storage

Image 2: Low Lying Area

Provide secondary containment for used oil storage. Within 30 days of the audit report, provide images of waste storage in secondary containment.

Remove trash/debris from drainage/low area, and install erosion controls to prevent erosion of the parking lot and sediments. **Within 30 days of the audit**, provide images of drainage area.
