## FIELD OBSERVATION REPORT #4

<b>PROJECT Kalmia Dr – Lake Park</b>	
<b>PROJECT NO: 18187.01</b>	<b>DATE: 5/06/2019</b>
<b>CONTRACTOR: Hinterland</b>	<b>ARRIVAL TIME: 9:00am</b>
<b>TYPE OF OBSERVATION: Final</b>	<b>DEPARTURE TIME: 11:30 am</b>

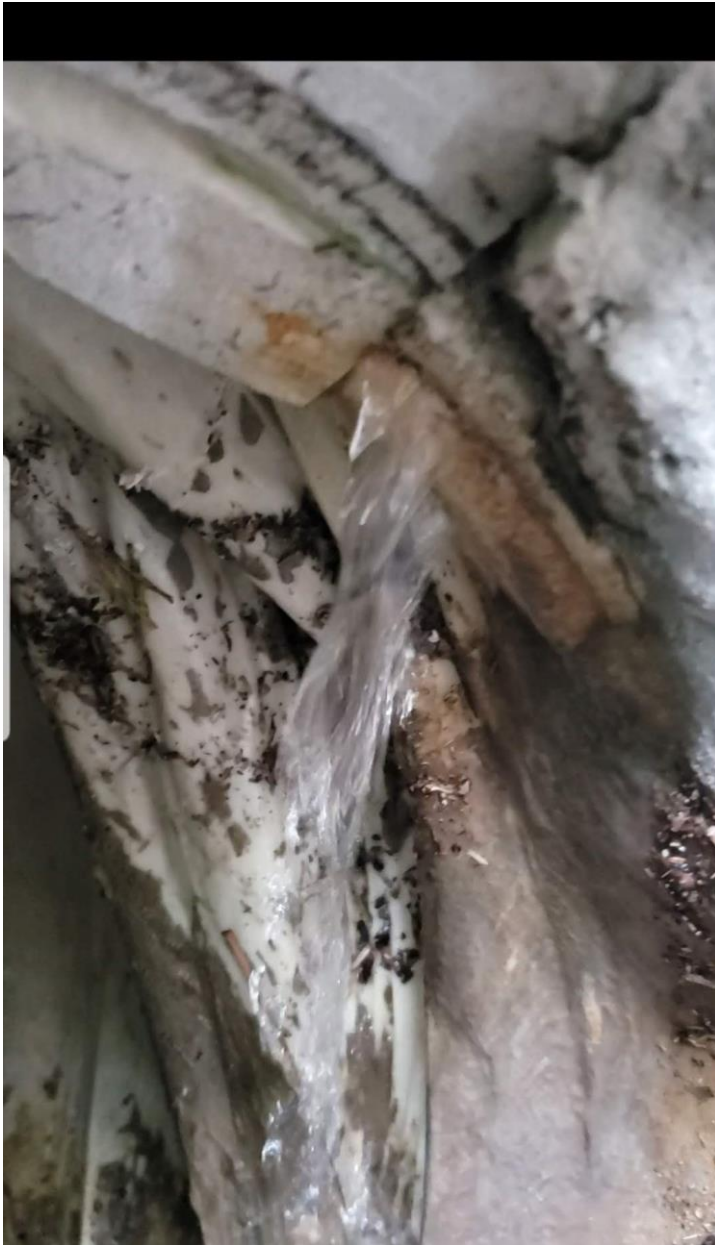
**Catch Basin #3 – Leak at 36” Lined Pipe**

- 1) A constant flow from the new 15" RCP into Catch Basin #1. The Town and EOR are requesting a POST video of this new pipe to help identify where the infiltration is coming from. Contractor to schedule TV inspection with the Town officials as the Town is requesting to be present during the entire length of the video inspection.
- 2) At Catch basin #3, there is a leak with heavy flow at the end of the 36" recently lined pipe where the wrinkled liner meets the concrete. There is a heavy flow from ground water into the pipe. Contractor must repair this lined pipe area. Suggestion of grout injection at this area to avoid future sink holes in the asphalt area which was the origin of these required improvements.

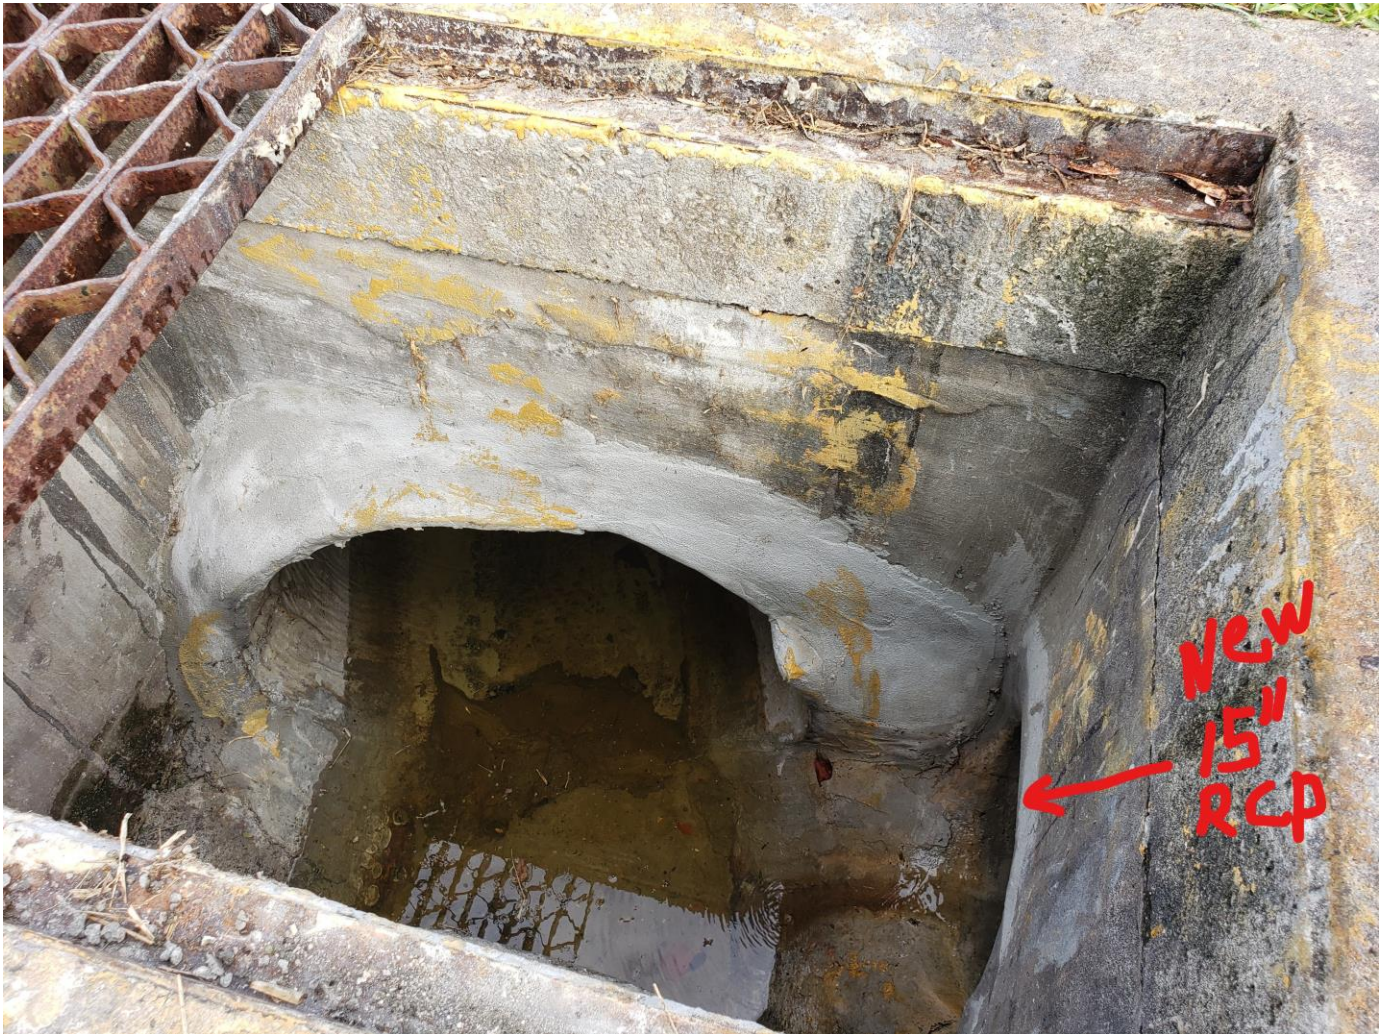
**CB #1 - Possible infiltration at one or more of the joints of new 15" RCP**

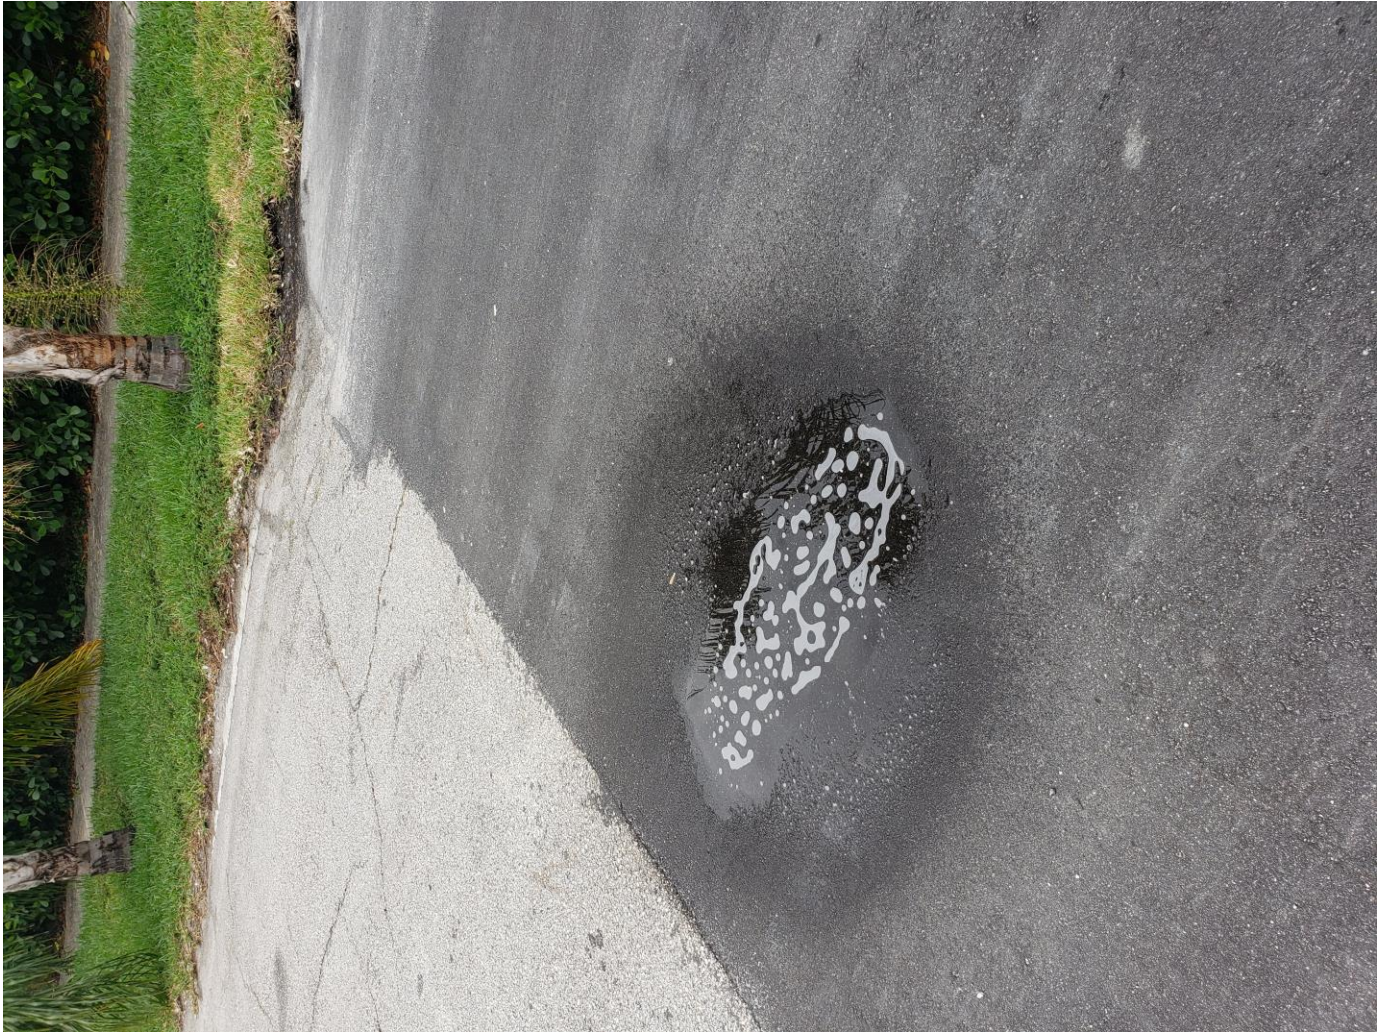
\*It was also noted the two low areas in the pavement patch were still present.

**Low area of the new pavement patch**

(\*This area should be checked for possible water infiltration at the new 15" RCP)
